## CASE STUDY

# Weathersealing EIFS

The Towers, Mesa, Arizona, United States

Hyatt Regency, Phoenix, Arizona, United States

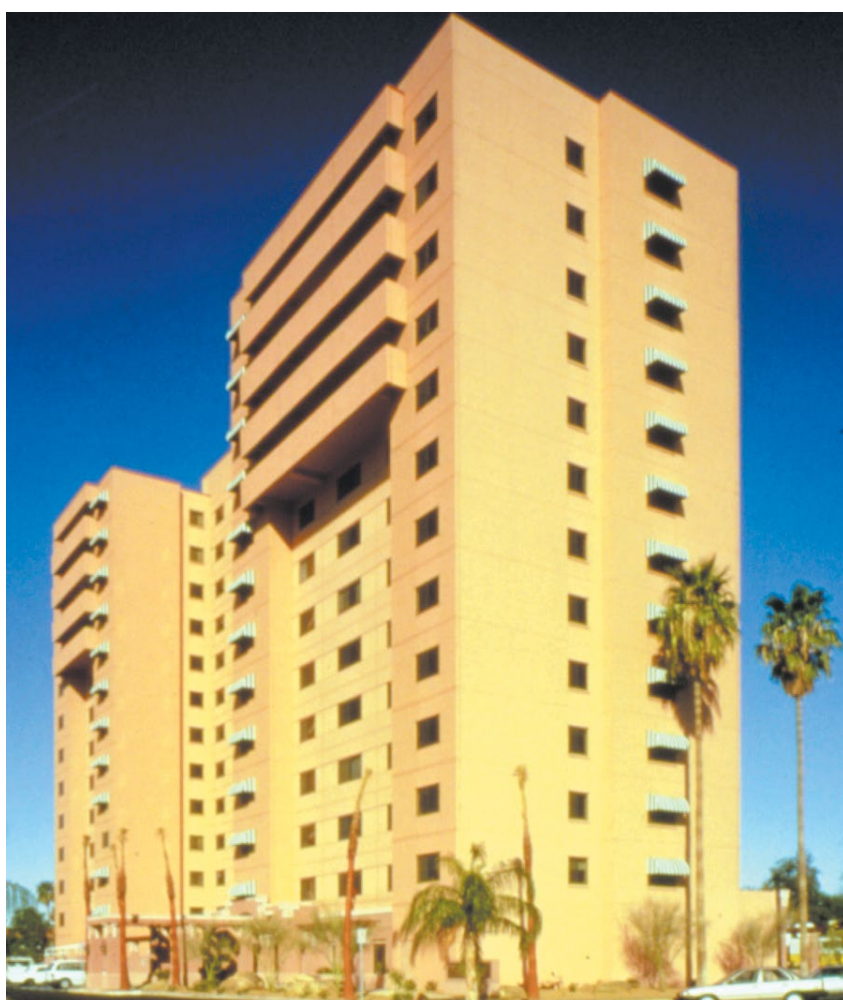
The Towers, Mesa, Arizona

Years of waterproofing repairs with urethane sealants had not cured persistent leaks in a 22-story apartment building in Mesa, Arizona. The repairs gave the building a patchwork look, and still let in rain during storms. As water infiltration continued through the joints, some of the structure’s Exterior Insulation and Finish System (EIFS) panels began to deteriorate. The building was only about 12 years old.

“The nature of the problems led us to recommend DOWSIL™ 123 Silicone Seal and DOWSIL™ AllGuard Silicone Elastomeric Coating,” said Matt Shane of SpecTech Systems Corporation. “By using DOWSIL™ 123 Silicone Seal in the 2-inch width, we proceeded without having to remove the old sealant.” With no need for labor-intensive removal of failed sealant, renovation went faster and cost less.

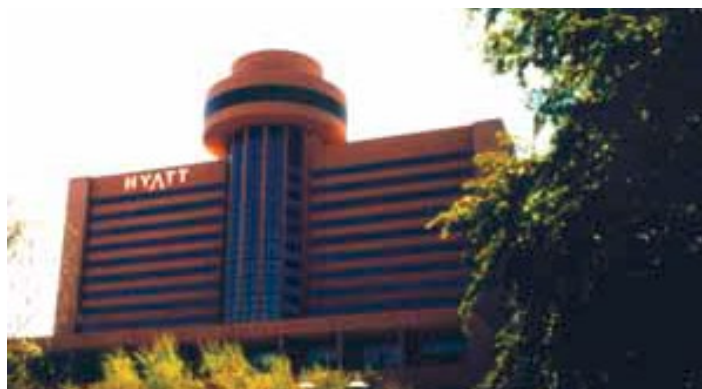
Hyatt Regency, Phoenix, Arizona

In 1997, it was obvious that 20 years of sun, heat and torrential rain had taken their toll on the glass curtainwall, stucco, split block, and EIFS exterior of the Hyatt Regency in Phoenix, Arizona.

To repair the problems, Jerome O’Connor, then consulting engineer for Law Engineering and Environmental Services, Inc., of Itasca, Illinois, recommended a complete building envelope solution. O’Connor recommended DOWSIL™ 795 Silicone Building Sealant for wet sealing window glass to frames; DOWSIL™ 790 Silicone Building Sealant for joints between stucco panels and to pre-seal larger cracks in the stucco; DOWSIL™ 123 Silicone Seal for the horizontal joints between the strip windows and the stucco panels as well as the gaps at the elevator shafts; and DOWSIL™ AllGuard Silicone Elastomeric Coating to waterproof the building’s various substrates.

SpecTech Systems Corporation of Bradenton, Florida, performed the job in about four months. Control joints were stripped, filled with new backer rod, and sealed with DOWSIL™ 795 Sealant. Primer and two coats of DOWSIL™ AllGuard were applied.
