CASE STUDY

Weathersealing EIFS

The Towers, Mesa, Arizona, United States

Hyatt Regency, Phoenix, Arizona, United States

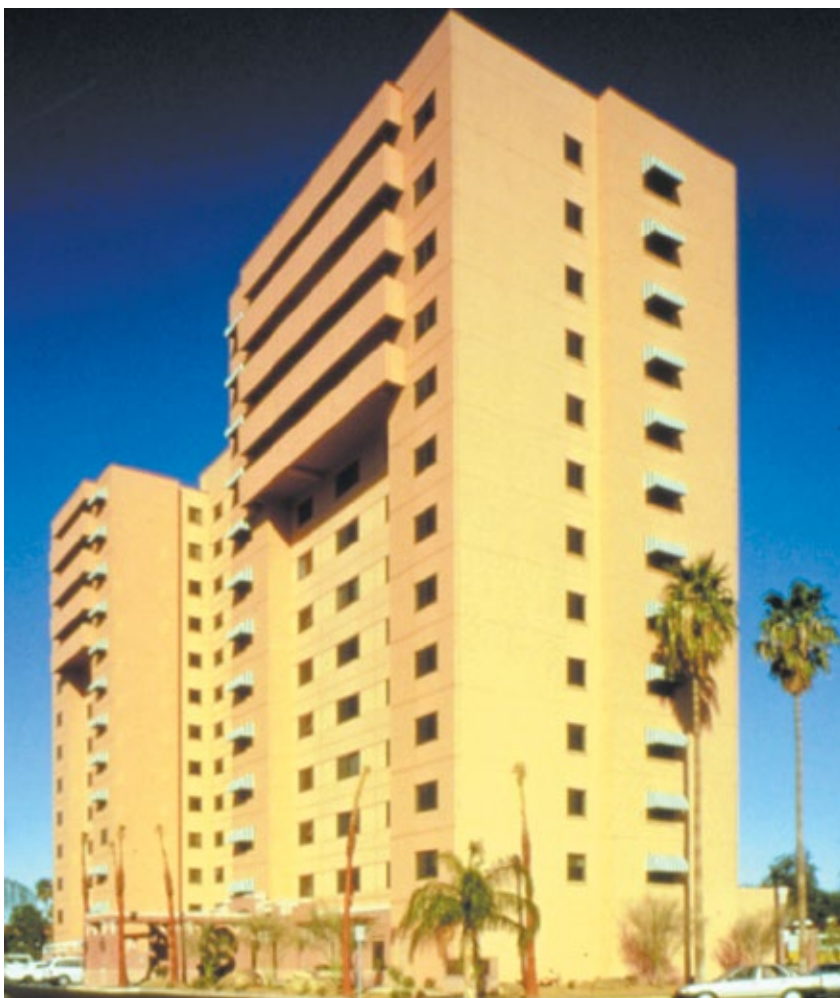
The Towers, Mesa, Arizona

Years of waterproofing repairs with urethane sealants had not cured persistent leaks in a 22-story apartment building in Mesa, Arizona. The repairs gave the building a patchwork look, and still let in rain during storms. As water infiltration continued through the joints, some of the structure’s Exterior Insulation and Finish System (EIFS) panels began to deteriorate. The building was only about 12 years old.

“The nature of the problems led us to recommend DOWSIL™ 123 Silicone Seal and DOWSIL™ AllGuard Silicone Elastomeric Coating,” said Matt Shane of SpecTech Systems Corporation. “By using DOWSIL™ 123 Silicone Seal in the 2-inch width, we proceeded without having to remove the old sealant.” With no need for labor-intensive removal of failed sealant, renovation went faster and cost less.

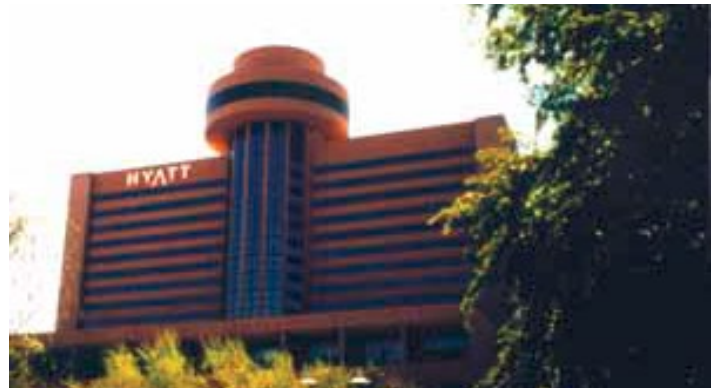
Hyatt Regency, Phoenix, Arizona

In 1997, it was obvious that 20 years of sun, heat and torrential rain had taken their toll on the glass curtainwall, stucco, split block, and EIFS exterior of the Hyatt Regency in Phoenix, Arizona.

To repair the problems, Jerome O’Connor, then consulting engineer for Law Engineering and Environmental Services, Inc., of Itasca, Illinois, recommended a complete building envelope solution. O’Connor recommended DOWSIL™ 795 Silicone Building Sealant for wet sealing window glass to frames; DOWSIL™ 790 Silicone Building Sealant for joints between stucco panels and to pre-seal larger cracks in the stucco; DOWSIL™ 123 Silicone Seal for the horizontal joints between the strip windows and the stucco panels as well as the gaps at the elevator shafts; and DOWSIL™ AllGuard Silicone Elastomeric Coating to waterproof the building’s various substrates.

SpecTech Systems Corporation of Bradenton, Florida, performed the job in about four months. Control joints were stripped, filled with new backer rod, and sealed with DOWSIL™ 795 Sealant. Primer and two coats of DOWSIL™ AllGuard were applied.
